RDT 00-009

Evaluation of Undersealing and Diamond Grinding Rehabilitation

RI86-002 and RI96-017

MISSOURI DEPARTMENT OF TRANSPORTATION
RESEARCH, DEVELOPMENT AND TECHNOLOGY

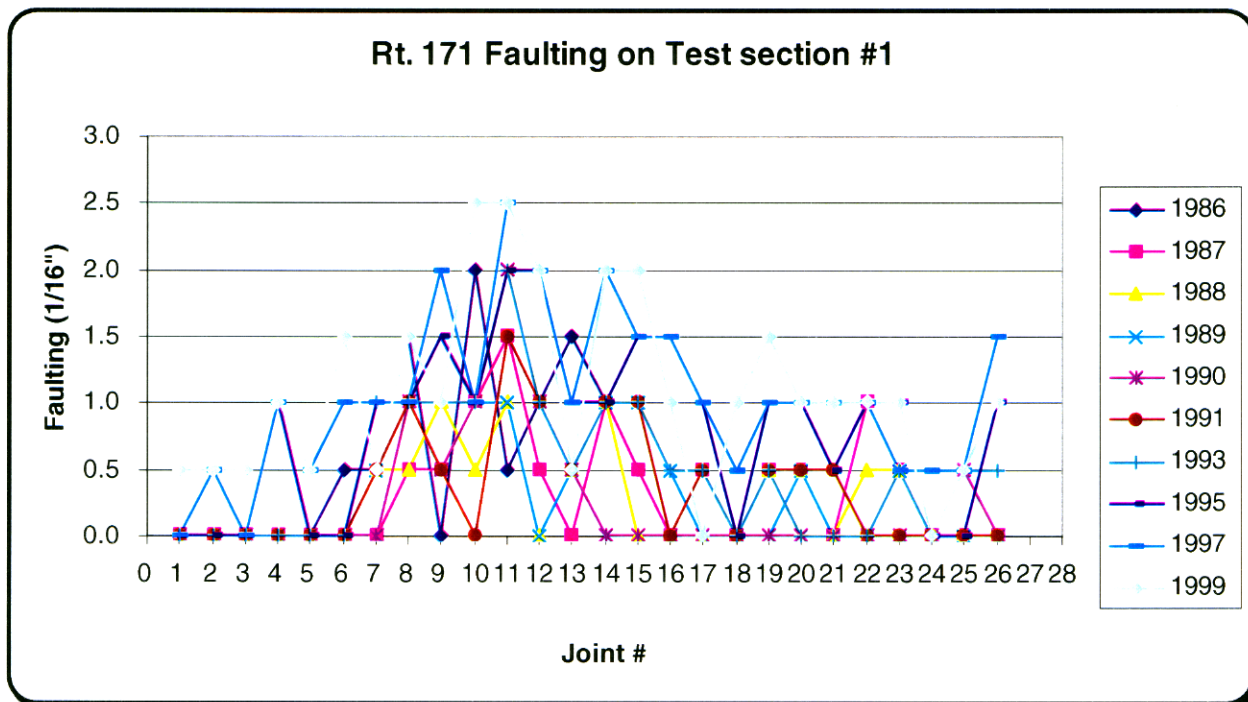
FIGURE 1 Rt. 171 faulting history on Test Section #1

Faulting on the Rt. 171 test sections has increased at a slight pace since 1985. Figures 1 and 2 illustrate the progression at each joint. Each joint fault measurement on the graphs is the average of faulting in the inner and outer wheel paths.

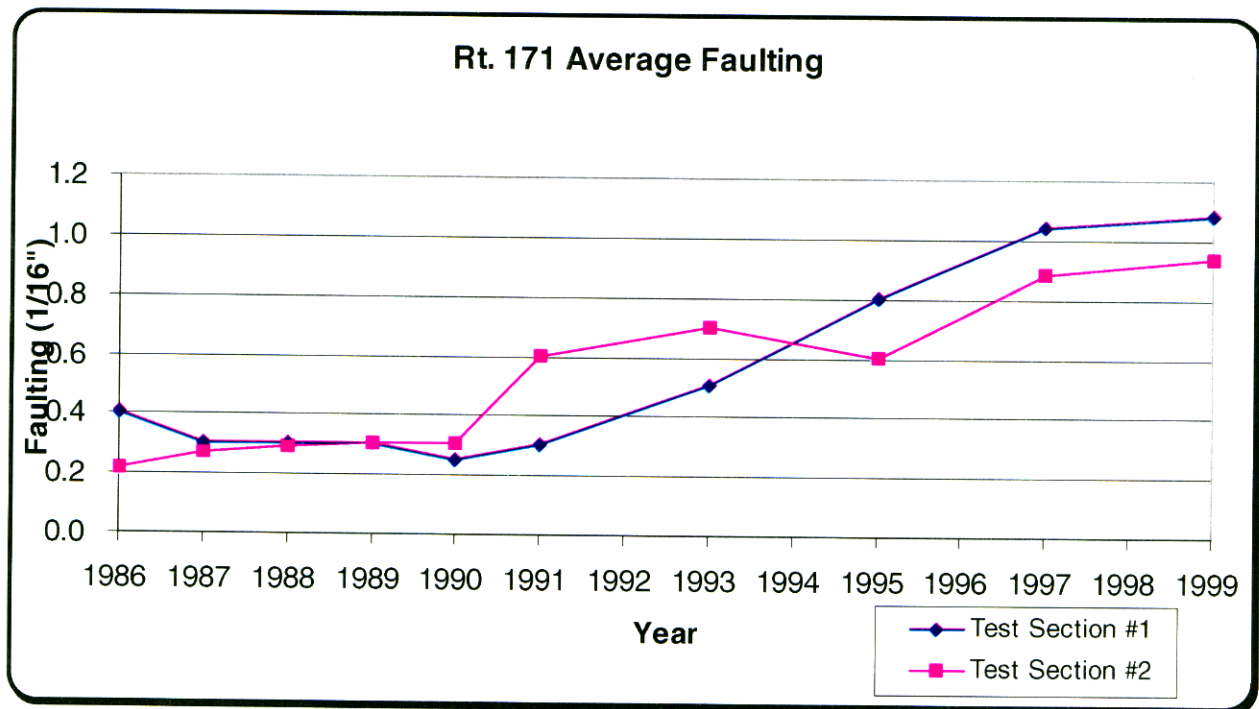
FIGURE 3 Rt. 171 annual average faulting on Test Sections #1 and #2

Average faulting for the entire Test Section #1 (TS1) is slightly over $1/16''$, while average faulting for the entire Test Section #2 (TS2) is slightly under $1/16''$, as shown in Figure 3.

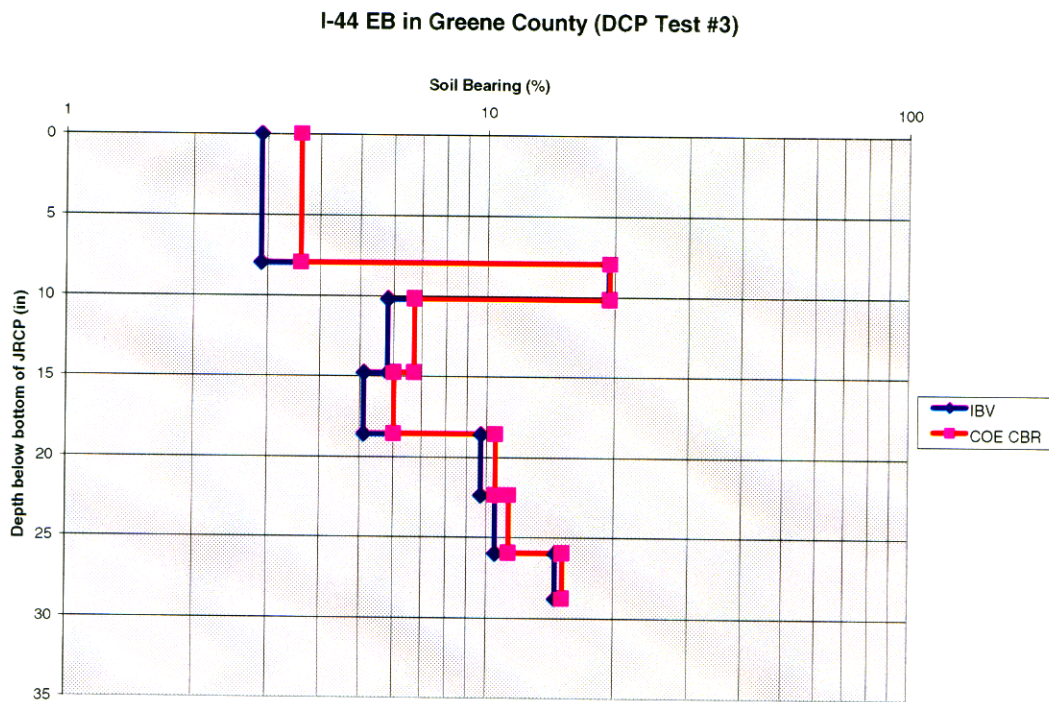
FIGURE 4 DCP results on EB I-44 under old PCCP

Figure 4 shows rapid DCP penetration under an old section of PCCP after getting past the base material. Figure #5 shows similar results under a recent repair patch, but the immediate high penetration indicates a loss of base material. Both figures clearly illustrate the poor condition of the top 6"-7" of the subgrade.

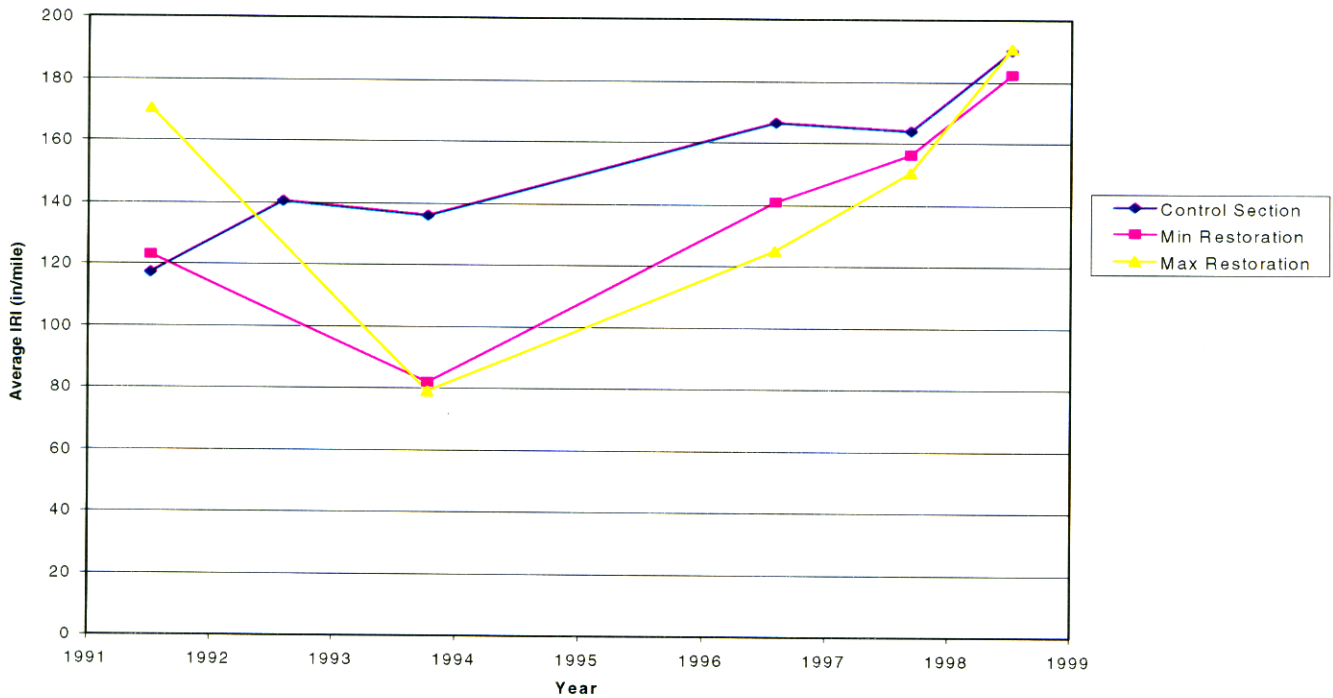
FIGURE 6 I-35 SPS-6 test section IRI performance history

relates to ride (4). Figure 6 shows how the ride on both the minimum and maximum restoration sections at first decreased substantially to a fairly smooth level, but within seven years deteriorated to a level nearly equal with the control section. The initial IRI measurements were taken prior to restoration. Some full depth patch repairs were performed in 1995, but did not appear to interrupt the progression toward higher IRIs.

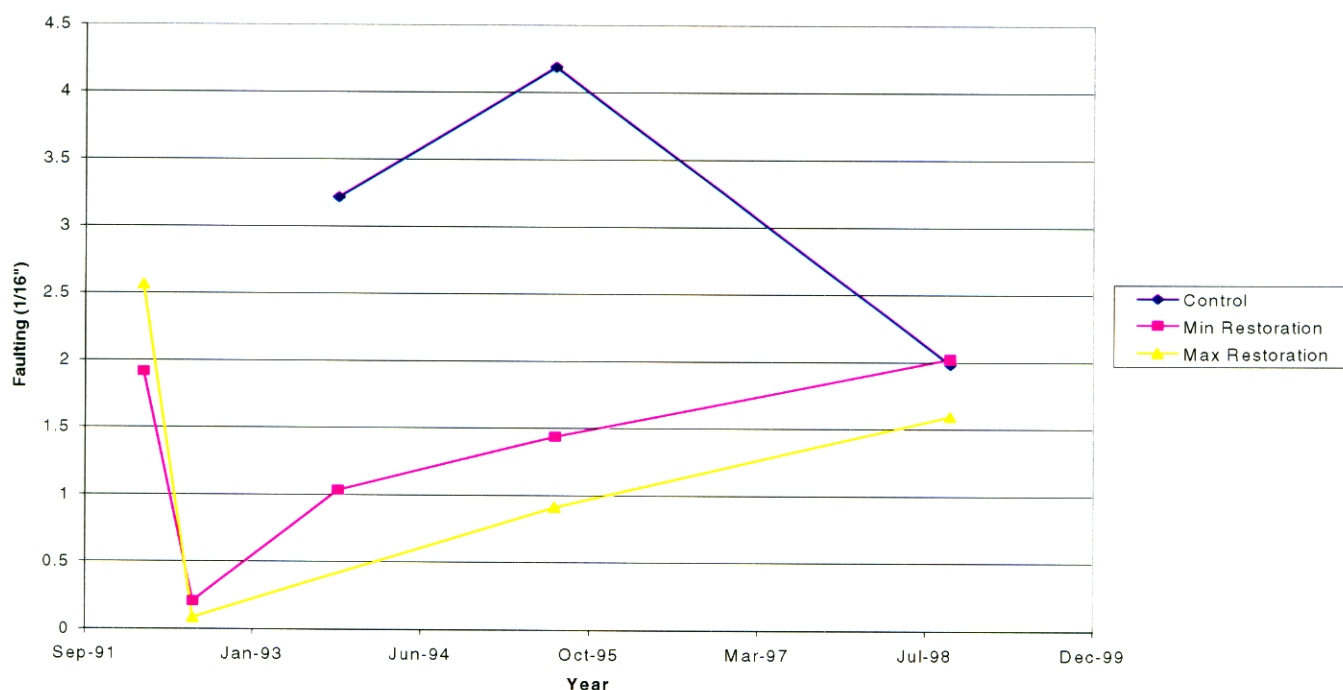
FIGURE 7 I-35 SPS-6 test section faulting performance history

Prior to construction, faulting did not exceed 5/16" at any location on the minimum restoration section and did not exceed 7/16" at any location on the maximum restoration section. The results of the subsequent surveys are shown in Figure 7. The August 1992 survey, conducted soon after construction, indicates virtually no faulting at the joints of the two restoration sections. The full depth patch repairs performed in 1995 occurred mostly at transverse cracks and did not result in any noticeable improvement in joint faulting. The control section underwent multiple maintenance repair operations, which explains the noticeable improvement after 1995. Average wheel path faulting measured during the last survey shows the three sections approaching the same value.
